Safety Notice

GALAXY[®] GX2 Automated Test System for ALTAIR[®] 5X Instruments

November 13, 2017

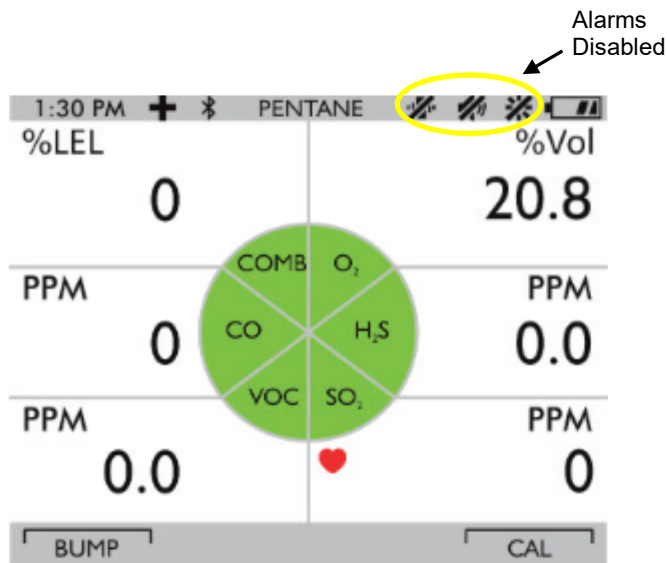
When these criteria are met, it has been found that the time to complete automated testing is longer than expected. Times up to 35 minutes have been observed. During this testing, the alarms of the instrument are disabled to eliminate nuisance alarms. If the instrument is removed from the GALAXY GX2 Automated Test System before the test is completed, the alarms will remain disabled.

If this occurs, the instrument display will indicate that the alarms are disabled (reference Figures 1 and 2). Turning the instrument off and then back on will result in the alarms being enabled again.

Figure 1: Color Display Showing Alarms Disabled

To address affected GALAXY GX2 Automated Test Systems, upgrade to the Firmware version available on the product software download webpage, which can be accessed via www.msasafety.com as shown in Figure 5. This will be version 1.08 until an updated Firmware version is available. Install the Firmware per instructions on the product software download webpage.

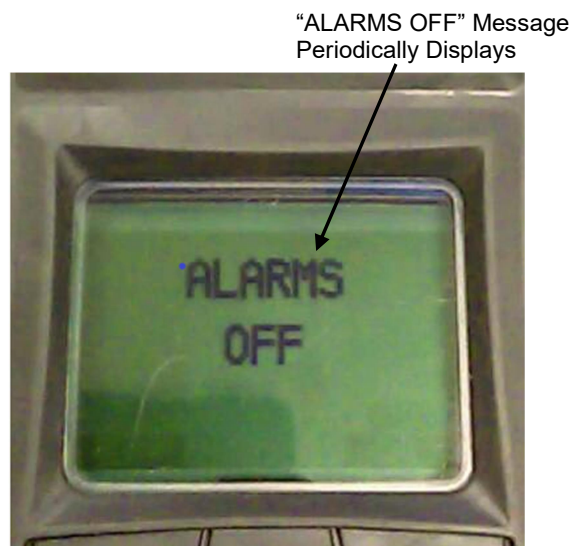
Figure 2: Monochrome Display Showing Alarms Disabled

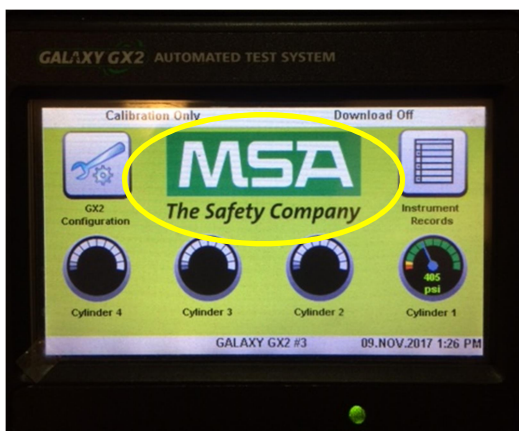
Figure 3

To check the Firmware version, press the MSA logo on the test system screen (reference Figure 3). The screen will then show the Application Firmware version (reference Figure 4).
