Inspection Notice MSA Latchways Web PFLs

April 29, 2019

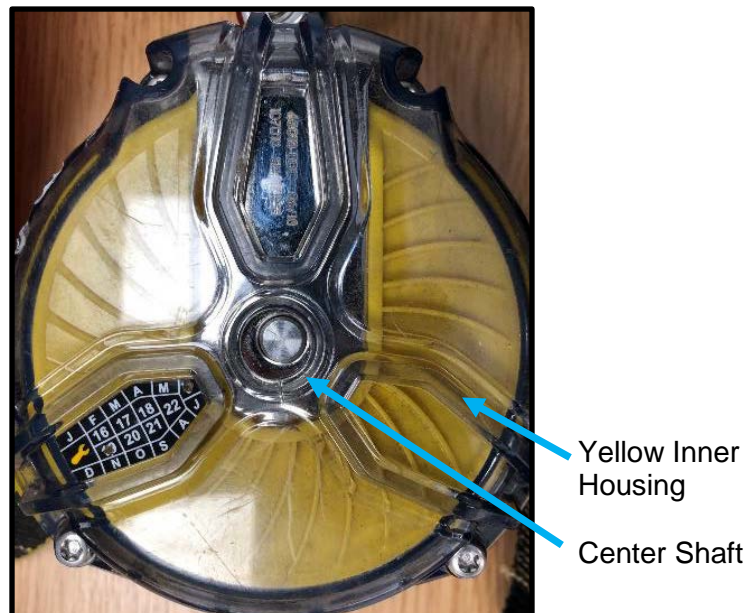
Figure 1 – Unflared Center Shaft

MSA is issuing this Inspection Notice to inform you that MSA has received a field report of an unflared center shaft in an MSA Latchways 10 ft. (3m) web PFL. **MSA has not received any reports of injuries associated with this condition. However, we are requesting that you perform the inspection outlined in this notice.**

If subjected to rough handling, an unflared center shaft may eventually dislodge completely from the web PFL. If the shaft dislodges completely from the web PFL, the web PFL will continue to pay out and retract during normal use, but will not arrest a fall.

- 1) Confirm that the web PFL has a yellow inner housing (see Figure 1). If your web PFL does not have a yellow inner housing, no further action is required.

Inspect per the Instructions in this Notice. Remove from service any web PFL that does not pass the inspection.

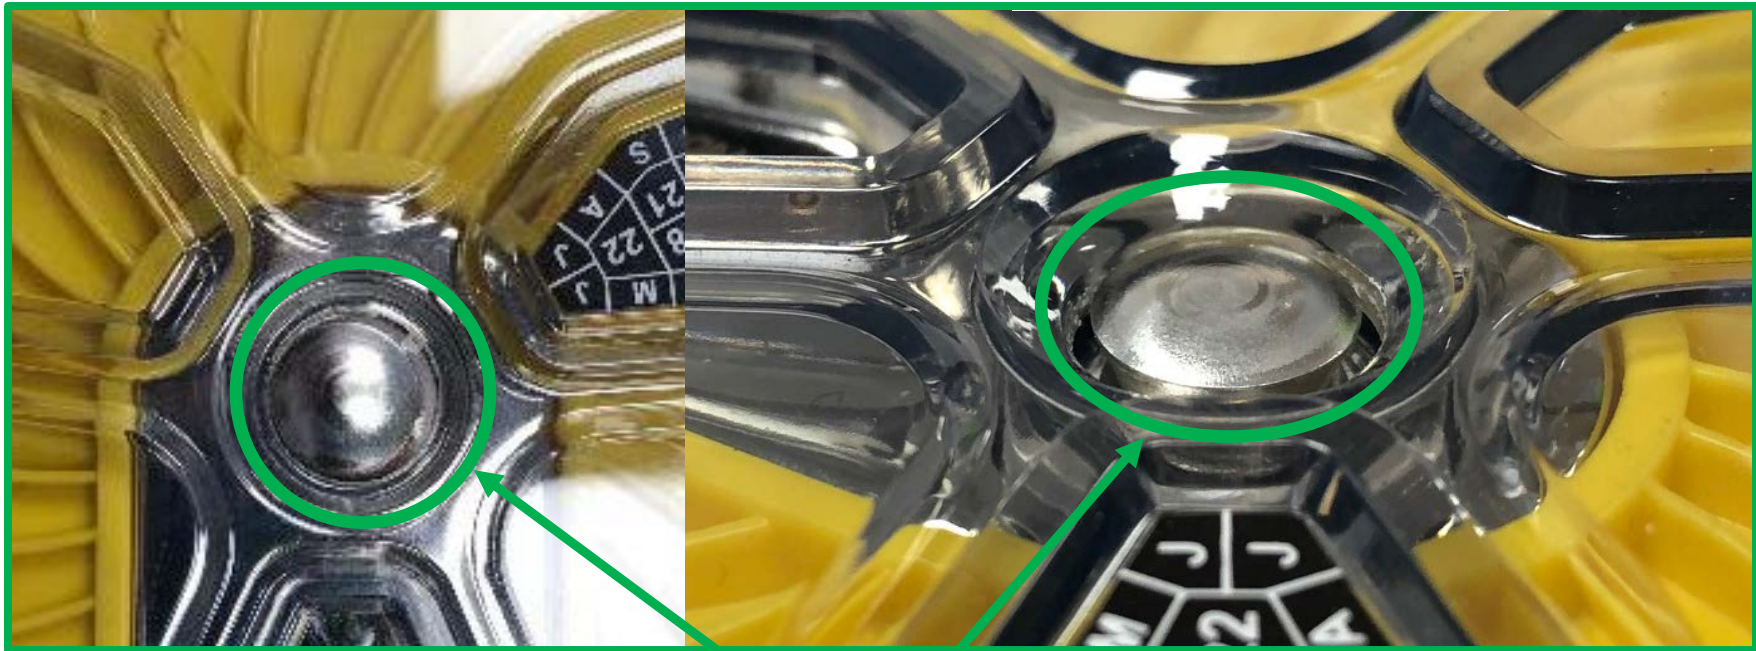
Figure 2 – Flared Shaft End

- 2) Inspect the shaft end that is on the same side of the PFL as the yellow inner housing.
 - a. Visually inspect the shaft for a flared end, as shown in Figure 2. If the shaft has an unflared end, as shown in Figure 3, **remove the PFL from service** and follow the steps in the “Replacing Affected PFLs” section.

Perform Inspection Step 2b to Confirm Acceptable

- b. If the PFL is not removed from service in step 2a, perform the following confirmatory test for an unflared end. With no load on the PFL lifeline and while holding the PFL in your hand, push on the end of the shaft on the yellow inner housing side of the PFL as if pushing the shaft out of the hole in the PFL. Some small axial movement of the shaft is normal. If the shaft can be pushed into the PFL and pulled out the other side, **remove the PFL from service** and follow the steps in the “Replacing Affected PFLs” section.

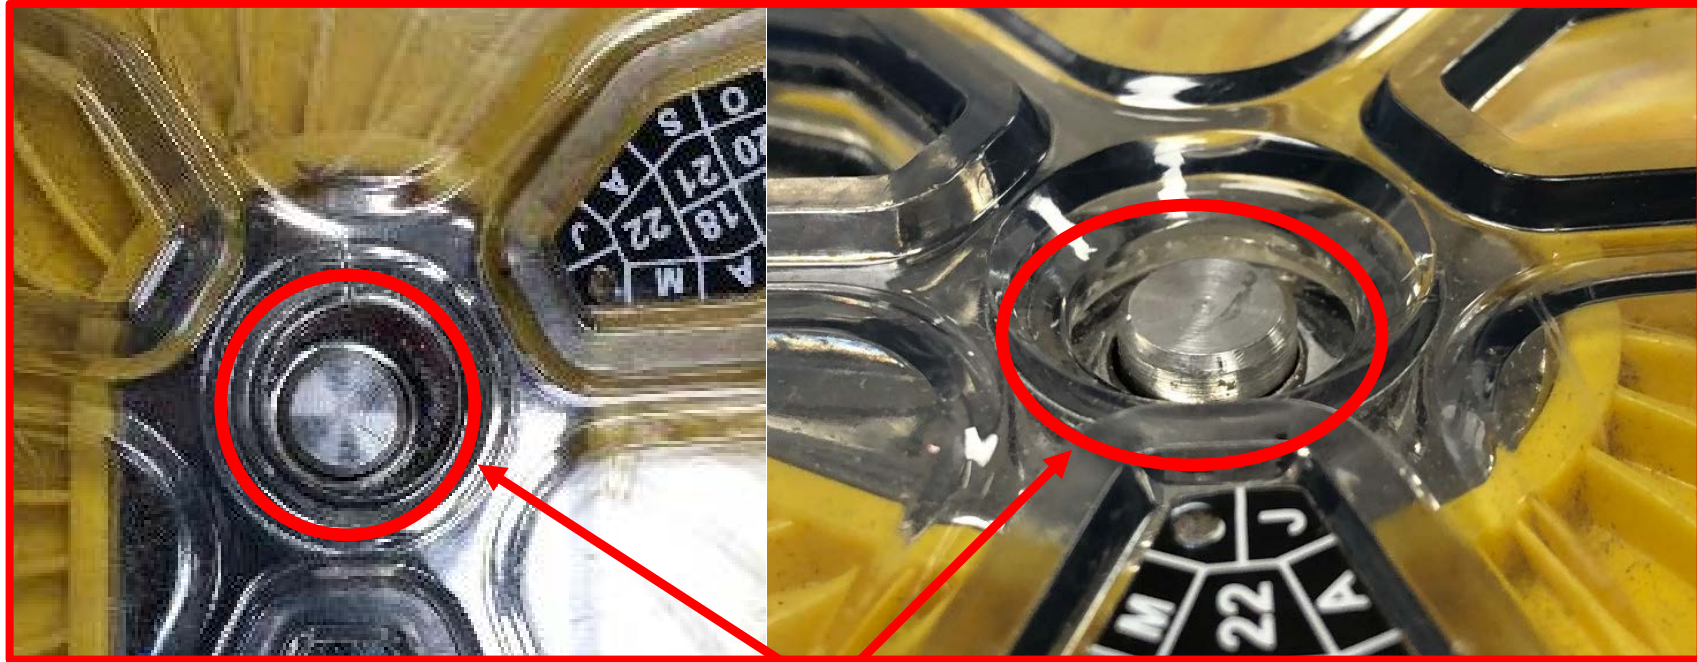
Figure 3 – Unflared Shaft End

REMOVE FROM SERVICE

If you are in possession of web PFLs that have an unflared center shaft, we will provide you with replacements free of charge.

To receive a replacement, please complete the enclosed *MSA Latchways Web PFL Return/Replacement Form* and e-mail it to MSA Customer Service at the appropriate e-mail address below. Replacement PFLs will be shipped to you and we will forward you instructions for returning the affected PFLs.
