## Safety Notice

### **SCBA Universal Air Connection (UAC) and Quick-Fill® Hose Fittings**

June 10, 2016

PS15020-13

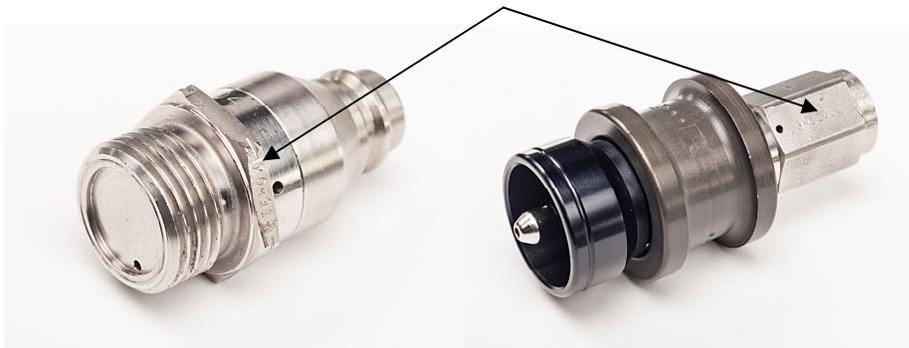
Affected fittings can be identified by Eaton's date code, which is marked on the fitting (see photos below). The first three digits of the date code are in Julian Date format for the specified year, which is indicated by the next two digits. For example, a fitting that is marked "060 15" would have been manufactured on March 1, 2015. If the date code on the fitting has six digits, read the first five digits.

- **Male Fitting** – MSA part number 485070, Eaton part number FD17-1082-10-04, Julian Date Codes – 060 15 through 243 15 (manufactured March 1, 2015 through August 31, 2015).
- **Female Fitting** – MSA part number 485071, Eaton part number FD17-1003-04-04, Julian Date Codes – 060 15 through 365 15 and 001 16 through 031 16 (manufactured March 1, 2015 through January 31, 2016).

Eaton's Date Code in Julian Date format is stamped on hex.  
Example: 060 15 (March 1, 2015)

**Male Coupling**

**Female Coupling**

**MSA is replacing all male UAC and female Quick-Fill fittings within the Eaton affected date range provided below. If you have any affected fittings, follow the steps provided in the Temporary Use of Affected Fittings section below and contact your local MSA Fire Service Distributor to arrange for installation of replacement fittings as soon as possible.**
